NRL Memorandum Report 3874

Failure Studies of a Third Stage Fan Disk From a TF-30 Turbine Engine

W. H. VAUGHAN, R. J. SANFORD, AND J. M. KRAFFT

November 13, 1978

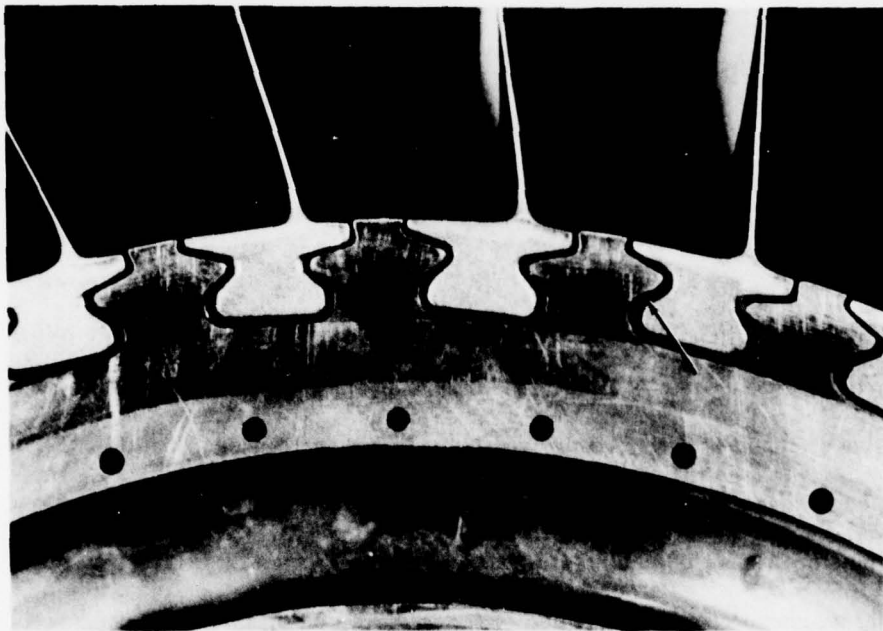
In recent years, the Navy has experienced unusual maintenance problems with its F-14 fighter aircraft. One of these is a tendency to develop cracks in the third stage fan disk of its TF-30 turbo-jet engines. These cracks typically originate in the dovetail region (Fig. 1) near the inner edge of the bearing surfaces between the disk and blades. A fully developed crack viewed from the leading edge of the dovetail is shown in Fig. 2. Cracks developed in this region after an unexpectedly short period of service. An investigation demonstrated a correlation between incidence of cracking and radial clearance between the second- to third-stage air seal. It was found that all of the failures had occurred in engines for which the clearance exceeded 0.025 in. (0.6 mm). This clearance was found to reduce the effective stiffness of the third stage disk, resulting in a strong 2E mode resonance within the operating speed range of the engine ($< 10,500$ rpm). This resonance results in vibratory stresses the order of 15 ksi (103 MPa) which, superposed on the high centrifugal stress, induce high frequency fatigue failures. A program to reduce the air-seal clearance has essentially eliminated this mode of failure and increased the service life of this part. However, fatigue cracking problems were found in other parts of the engine. Thus several studies were initiated at NRL to probe general aspects of the problem.

Fig. 1 — Side view of the intact portion of the third stage fan rotor showing the dovetail attachment of the blades. The arrow indicates the region where fretting occurs.

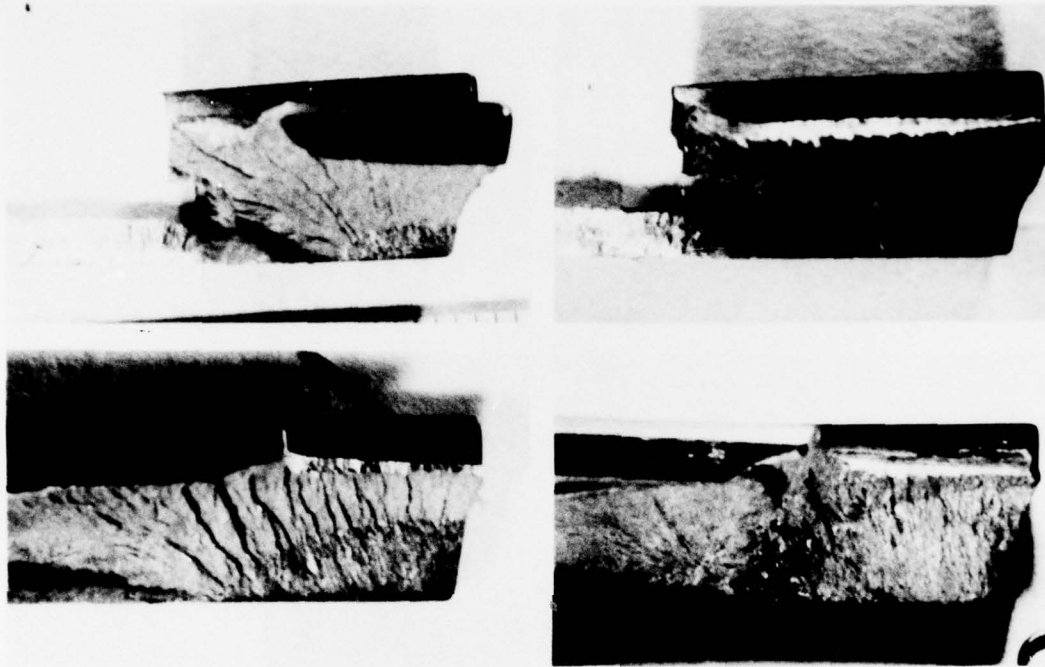
The fracture surface of each of the removed lugs was photographed at 3.25X and examined under a low-power binocular microscope. All of the cracks originated near the inboard edge of the bearing area with the majority (13) of them occurring on the left side of the disk lug (when viewed from the front). The exposed fracture surfaces revealed that the cracks are initially planar and follow the same path as shown on the surface of the lug (see Fig. 2). Four typical fracture surfaces are shown in Fig. 5. In the figure the front face of the disk is on the right and the lug has been rotated so that the fatigue crack is in the plane of photograph. As can be seen, the cracks have quarter-elliptical fronts, of a high length-to-depth ratio, centered

Fig. 5 — Typical cracks that started in the leading edge.

near the slot to front face intersection. The smoothness of the surface texture relative to the fast fracture region beyond the elliptical perimeter suggests that they grew as fatigue cracks, which later high-resolution examination verified. While most of the cracks emanated near the forward leading corner of the disk lug, a small crack (see Fig. 6) was found in the rear of a disk lug. The cracks originated in the fret zone or in the fillet region just below the fret zone. It appears that a given crack initiates at several points over a distance of the order of millimeters along the edge of the slot. This accounts in part for the relatively high ratio of the length of the crack along the disk slot relative to its depth in the lug. The pattern of growth as cracks progress from their origin is relatively consistent, as shown, Fig. 7, in an overlay of this series of various sized cracks.

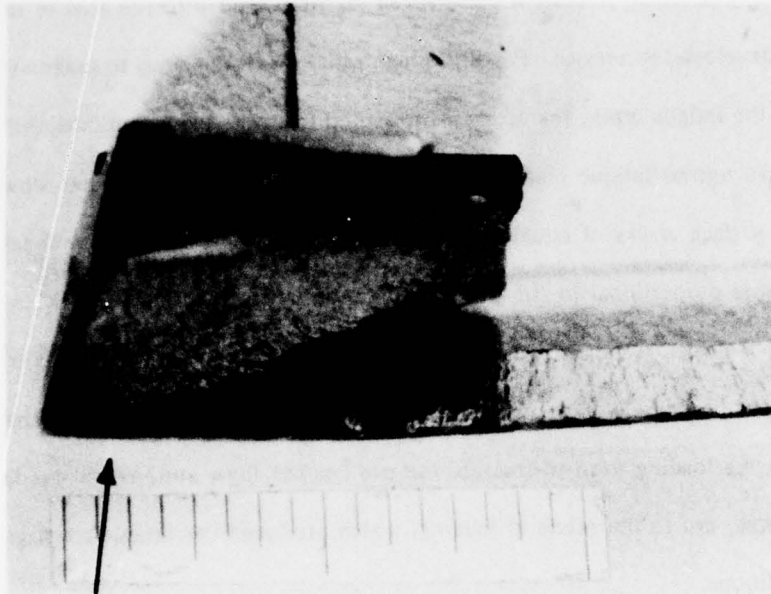
Fig. 6 — A typical crack that started in the trailing edge.

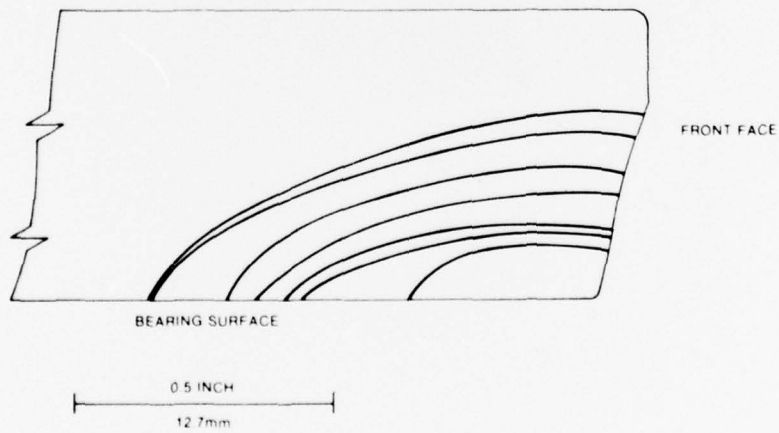
Fig. 7 — Tracings of the leading edge of seven cracks that developed in service. They appear to have a consistent pattern of initiation and growth.

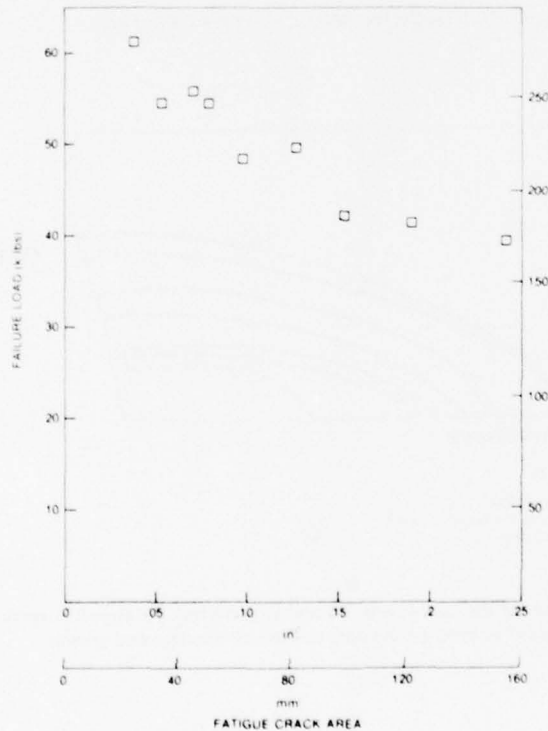
The force required to fracture a pre-cracked lug decreased with the area of the crack surface that had developed in service. For those lugs which fractured so as to make visible the initial surface of the fatigue crack, the area was measured from the low magnification photographs. The failure load versus fatigue crack area is shown in Fig. 8. Irwin [5] has shown that, for semi-elliptical surface cracks of equal aspect ratio, with loading normal to the crack, the stress intensity factor is proportional to the product of the breaking load and the fourth root of the crack area, A . The data used in Fig. 9 shows this dependency when plotted as $\sigma \sqrt[4]{A}$ versus crack area, where σ is the average stress on a lug at failure. It should be noted that this result applies only to the loading used to fracture the pre-cracked lugs, and, as will be demonstrated later in the report, not to the mode of loading, which produced the fatigue crack growth under in-service conditions.

Fig. 8 — The ultimate load to remove a lug as a function of the area of the crack that developed in service.

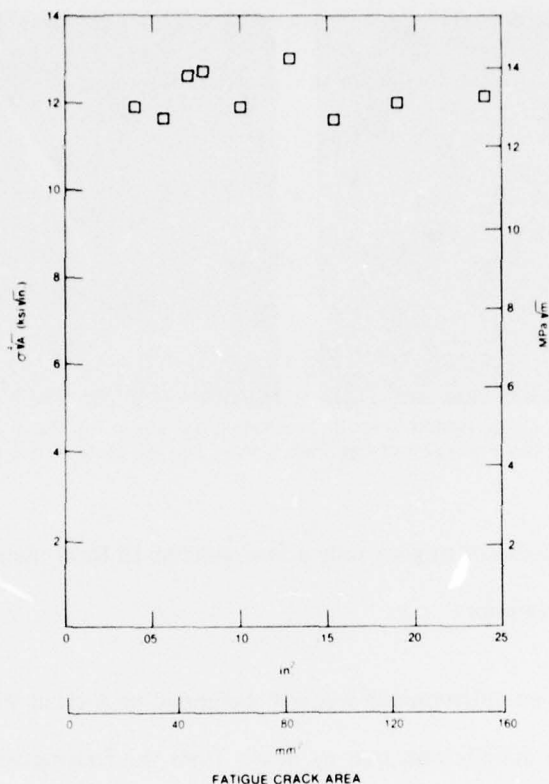
Fig. 9 — This shows that the fourth root of the product of the ultimate load and the crack area is a constant. However this was not the state of stress that occurred in service.

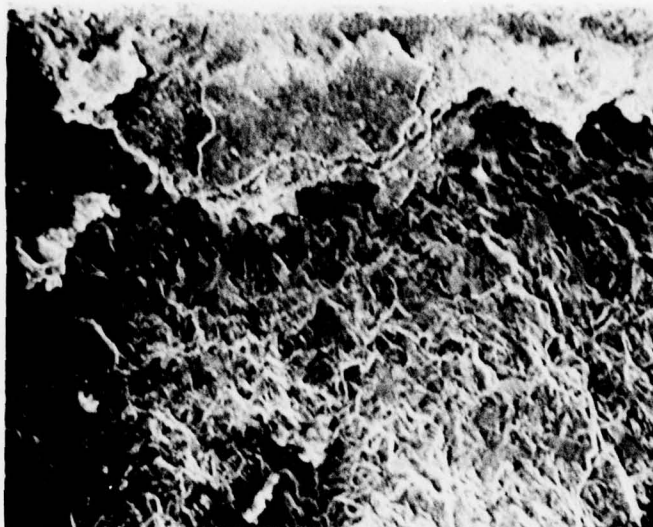
The region around an initiation site was also examined on a crack which had been broken open. The origins were initially obscured by debris from the fretting which had been forced into the crack and was adhering to the crack surface as illustrated in the upper portion of Fig. 11. This debris was stripped off by repeated application and removal of a polycarbonate replica material. The difference in visibility between an unstripped and stripped fracture origin is seen by comparing Fig. 11 and Fig. 12a. Once the debris was stripped away, it was found that the shape of the grains is not clearly defined near the origin, as shown in Fig. 12b. It is possible that the loss of definition is due to abrasion of the fracture surface by fretting debris or to extensive plastic deformation at the fracture initiation site. It can be seen that the origin of the fracture surface is inclined at an acute angle to the bearing surface unlike the rest of the fracture surface which is essentially perpendicular to the bearing surface. This behavior is typical of fretting origins under the contact zone when shearing forces are present.

Fig. 11 — SEM micrograph (200x) showing typical fretting debris along the region where the multiple crack origins occurred

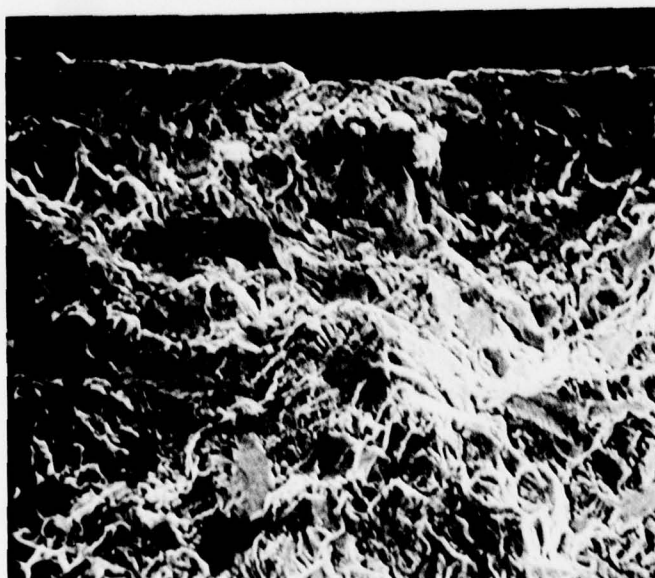
Fig. 12a — SEM micrograph (500x) showing the contrast in microstructure between the cleaned fracture origin at the top and the quasicleavage at the bottom

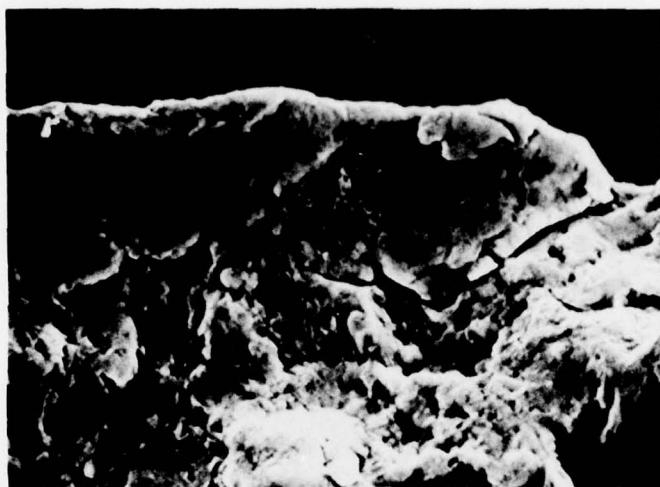
Fig. 12b — SEM micrograph (2k x) of the fracture origin shown in 12a

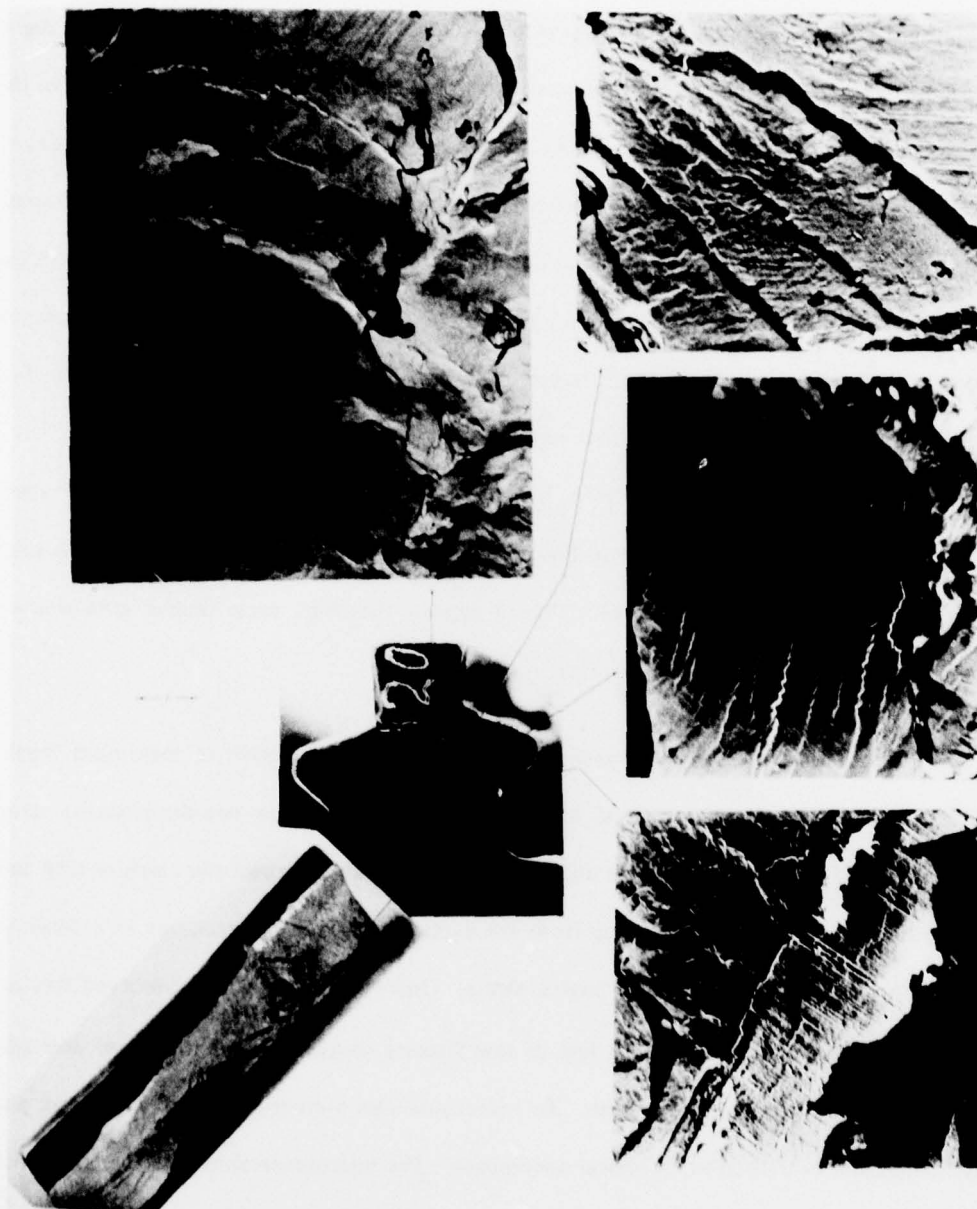
Figure 13 shows several TEM fractographs taken from various regions of the fatigue crack. It was anticipated that the striation spacings would become larger with distance from the surface, corresponding to the stress intensity factor increasing with crack length. Surprisingly, this was not the case. The striations which were formed all had low contrast and a constant spacing that averaged around $.04 \mu\text{m}$ on the portion of the fracture surface perpendicular to the bearing surface. Only after the fatigue crack turned tangentially across the lug did the striation spacing increase, becoming 2 to 5 times larger. These small striations are barely visible in Fig. 13. There is evidence of groups striations with spacings of the order of $0.5 \mu\text{m}$ (2×10^{-5} in.) in the initial stages of fatigue crack growth, increasing to $1.5 \mu\text{m}$ (6×10^{-5} in.) after the crack turns. These groups are clearly visible in Fig. 13. It is reasonable to associate these group spacings with low cycle engine fluctuations. Thus it appears that high cycle fatigue striations are superposed on low cycle engine fluctuations.

Fig. 13 — Examples of the fatigue striations found at the depths indicated by arrows. These micrographs were made in a TEM from replicas.

By comparing the photoelastically determined stress intensity factor with the observed striation spacing in the region of constant crack growth rate, several conclusions can be drawn concerning loading conditions during crack growth. If one assumes, contrary to the fractographic evidence that the loading was that of low cycle fatigue associated with engine speed fluctuations, the measured stress intensity of 14 ksi $\sqrt{\text{in.}}$ (15.4 MPa $\sqrt{\text{m}}$) at the maximum operating speed of 10,500 rpm would correspond to the upper bound on ΔK , i.e., K_{max} . Assuming large engine speed excursions of 50% or greater ($R \geq .5$), the ΔK would vary between 7-14 ksi $\sqrt{\text{in.}}$ (7.7-15.4 MPa $\sqrt{\text{m}}$). From the data of Bucci and Paris [8] this range of ΔK would correspond to crack growth rates of the order of 10^{-6} to 10^{-5} in./cycle ($\approx 10^{-7}$ mm/cycle). An examination of the fatigue crack fractography as shown in Fig. 12a, shows this region to consist predominantly of cleavage leaves with little dimple rupture. Yuen et al. [9] have shown that in titanium alloys cleavage is not produced at crack growth rates in the range of 10^{-5} in./cycle or faster. Therefore low cycle fatigue as the primary mechanism of crack growth must be ruled out. The presence of groups of striations as seen in Fig. 13 (upper left) is consistent with the

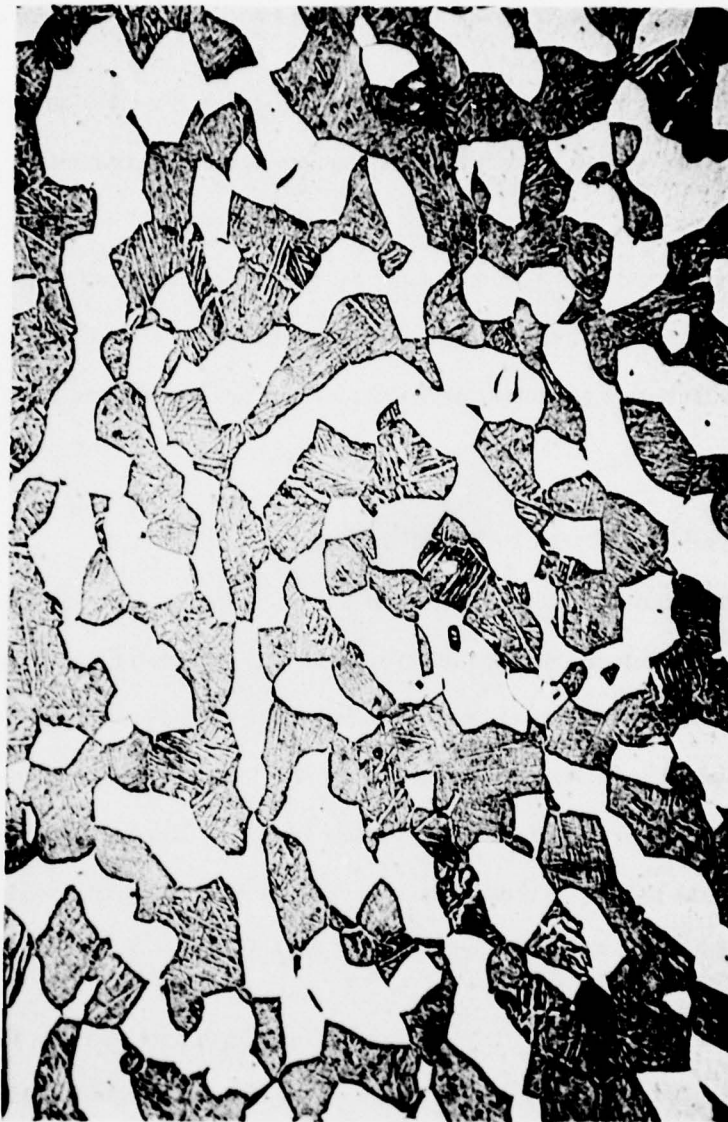
Fig 14 — Microstructure of the third stage fan lug. It is primary alpha in the light areas and acicular alpha plus beta in the dark areas. There is no evidence of a preferred orientation.

aluminum alloys which have been air-cooled from the alpha-beta transition region of the phase diagram. There is no evidence of a pattern of flow lines associated with the forging process.

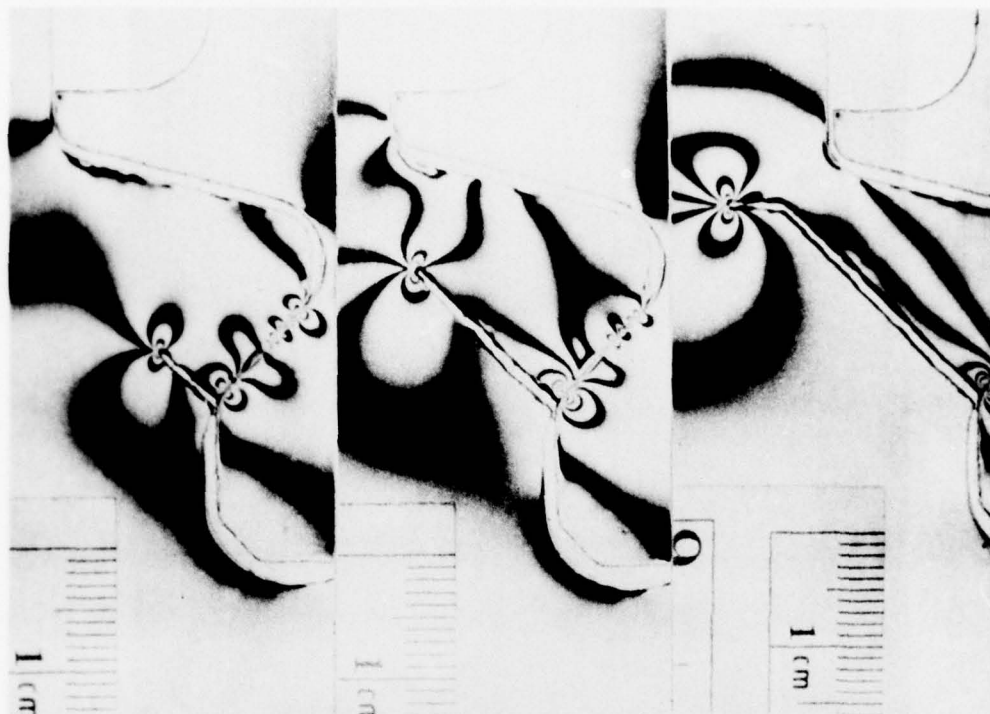
Typical isochromatic fringe patterns obtained during the test are shown in Fig. 15 with an enlargement of one of these in Fig. 16. Inspection of the fringe pattern of Fig. 16 indicates that the characteristic fringe loops associated with the stress singularity are not symmetric with respect to the crack line and that the fringe loops on either side of the crack line are rotated by different amounts. This configuration of the fringe loops indicates that the driving force on the crack has both opening (K_I) and forward shear (K_{II}) components. The observation that the

Fig. 15 — Isochromatic fringe patterns of the photoelastic model. They show little change in stress intensity until the simulated crack turned the corner.

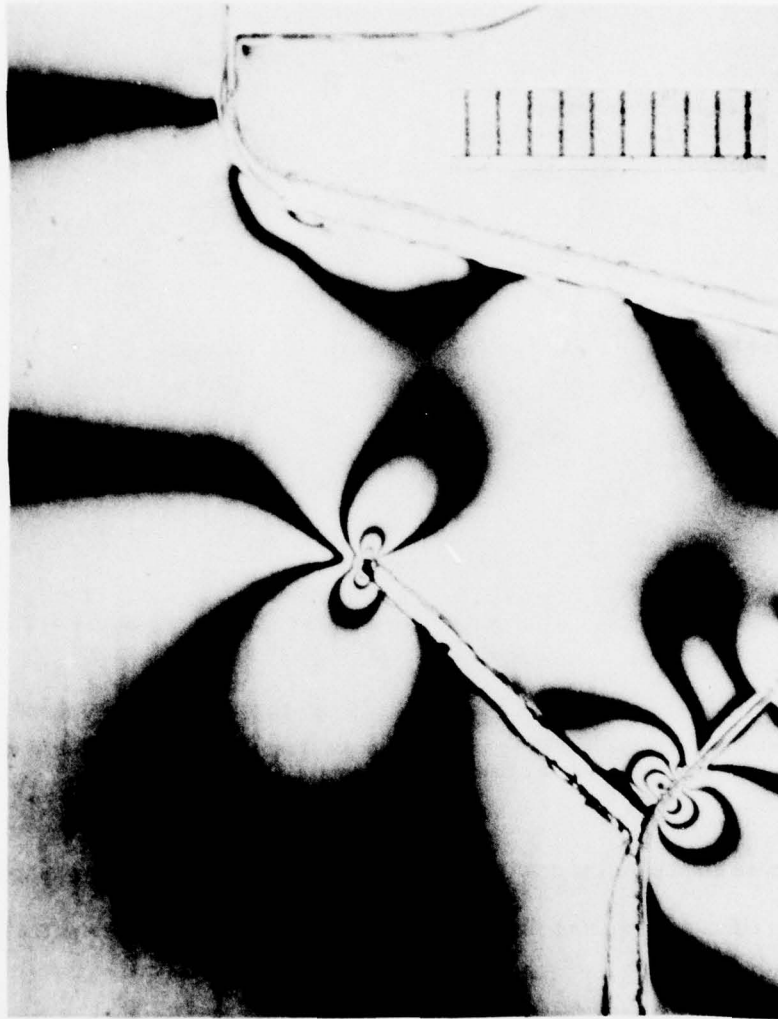
fringe loops above and below the crack line are of different size and different rotations indicates that there is an effect due to a non-singular stress component which complicates the analysis.

Fig. 16 — An enlarged view of the bottom photograph of Fig. 15. The evident asymmetry of the fringe pattern is indicative of the mixed mode state.

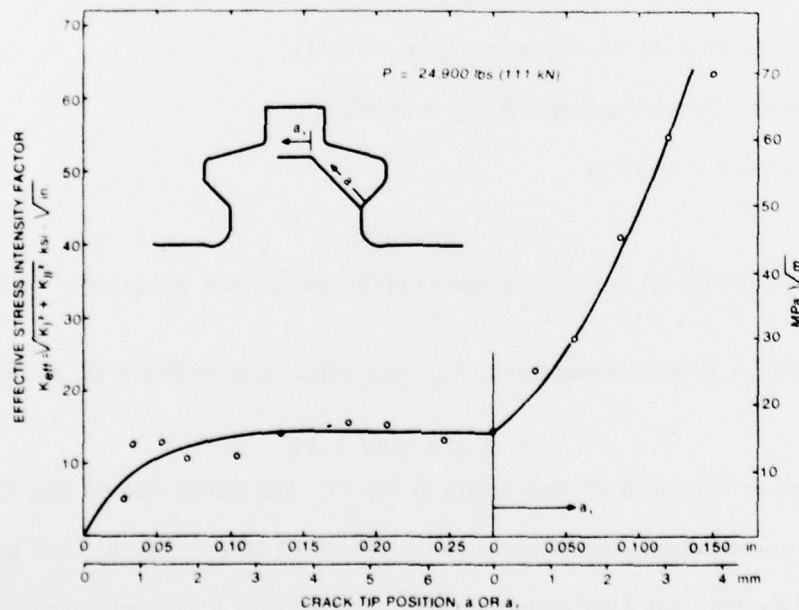
and is shown as a function of crack length in Fig. 17. The results indicate that K_{eff} increases from zero to a maximum value of about 14 ksi $\sqrt{\text{in.}}$ (15.4 MPa $\sqrt{\text{m}}$) as the crack penetrates the region near the fillet with a high stress gradient. The value of K_{eff} remains essentially constant as the crack extends into the lower stress region and propagates across the lug. As the crack

Fig. 17 — The effective crack tip stress intensity factor K_{eff} as a function of the position of the crack tip.

approaches the compressive fillet, K_{II} increases and K_I decreases (see Table 1) until the crack turns through an angle of 45 degrees and begins to propagate circumferentially. At this point K_I increases markedly and K_{II} decreases. With further increases in crack length K_{eff} increases to a value exceeding 60 ksi $\sqrt{\text{in.}}$ (66 MPa $\sqrt{\text{m}}$).
